Trip Report, 5600 South 900 East Plume, Murray, Salt Lake County, Utah.

TRIP REPORT

5600 S. 900 EAST PLUME Murray, Salt Lake County, Utah

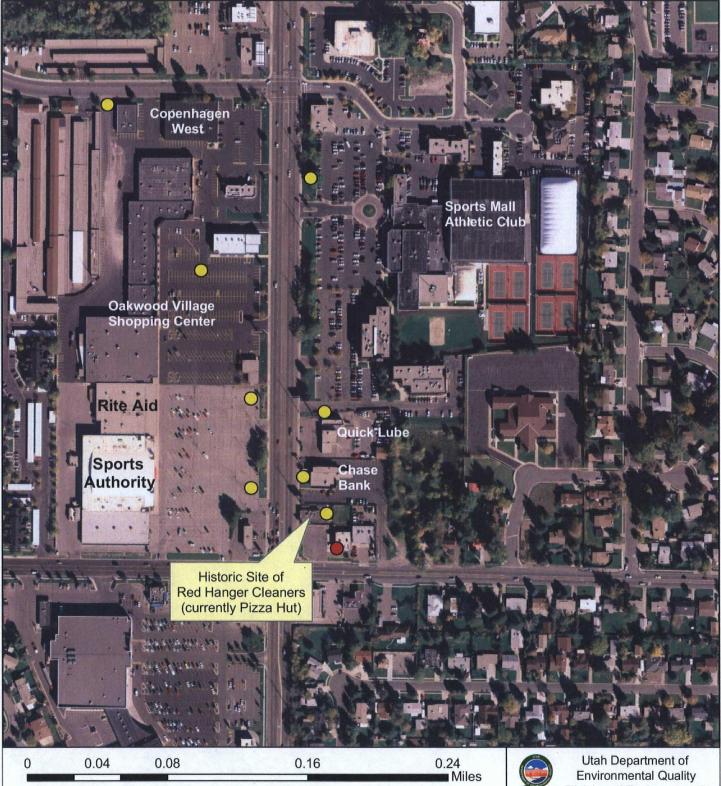
> Figure 4 Site Map

ATTACHMENT A UDEQ Proposed Site Location Map

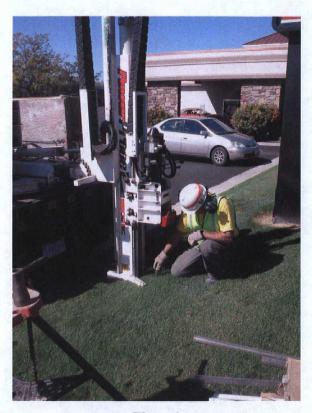
Photo 1
START member Henry Schmelzer prepares to add another length of rod to the borehole drilling at sample site number 7 (0926111451.jpg: 09/26/11).

Sample location number 7 near Harris Hearing Aids was the next borehole location. The borehole

produced dark gray sandy clay and lighter grey clayey sand to a depth of 8 feet. A temporary well was

installed and UDEQ collected soil and groundwater samples.

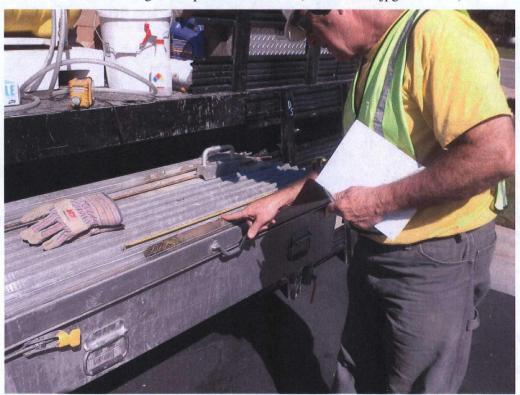
Photo 2
START member Schmelzer tests the soil core for moisture content at sample site number 7 (0926111454.jpg: 09/26/11).

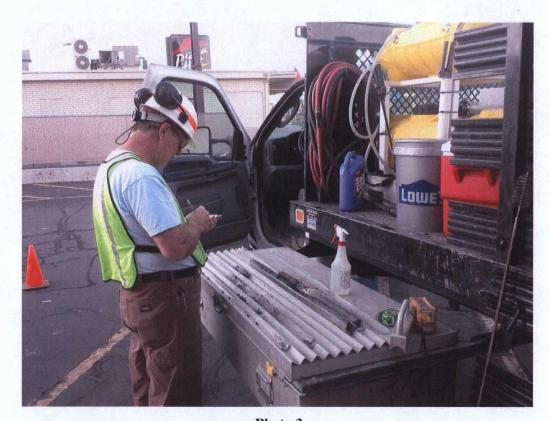
Photo 3
START member Schmelzer taking notation of the sample core lithology at sample site number 2 (0928110747.jpg: 09/28/11).

The next sample location was number 2 in the parking lot behind Pizza Hut. The borehole produced sand

that trended to moist grey sand to a depth of 12 feet. A temporary well was installed and UDEO collected

soil and groundwater samples.

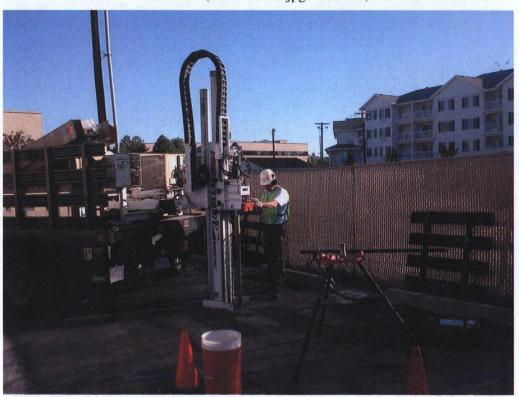
Photo 4
START member Schmelzer operating the Power Probe at sample site number 2 (0928110914.jpg: 09/28/11).

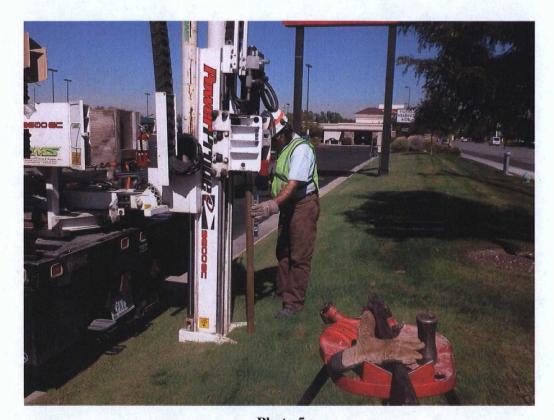
Photo 5
START member Schmelzer checks the deflection of the drill casing during the operation of the PowerProbe at sample site number 6 (0928111233b.jpg: 09/28/11).

START returned to sample location 6 in the parking lot of Sports Authority. The borehole produced moist

plastic sandy clay and a dark grey mix of sand and river pebbles to a depth of 12 feet. A temporary well

was installed and UDEQ collected soil and groundwater samples.
